# How to stop the rot? Continuous monitoring of short span timber bridges

Engineers Australia, Regional Convention - Grafton

# HOW TO STOP THE ROT? CONTINUOUS MONITORING OF SHORT SPAN TIMBER BEAM BRIDGES

John Moore, Rex Glencross-Grant and Robert Patterson  
University of New England, Armidale  
Corresponding Author's email: [jcm@internode.on.net](mailto:jcm@internode.on.net)

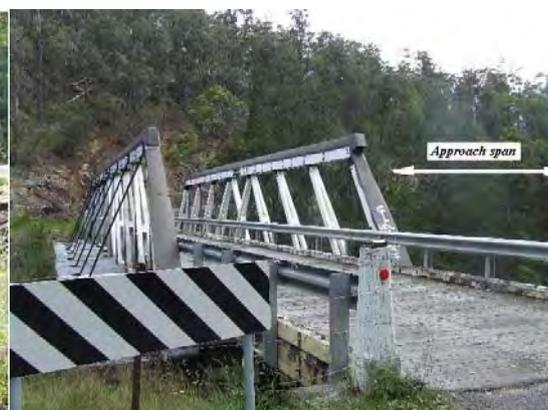
**Photo 2:** Example approach span, Styx River, Armidale-Kempsey Road, NSW

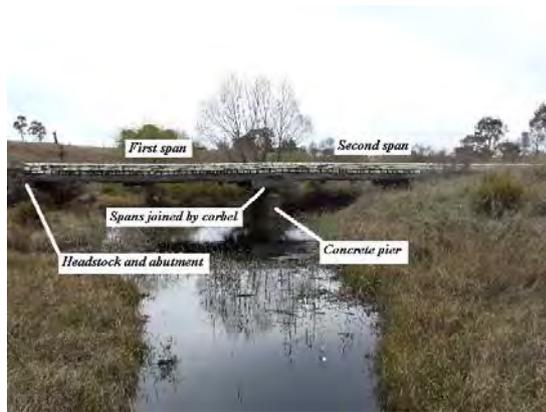
**Photo 3: Multiple spans corbelled together, Uralla NSW**

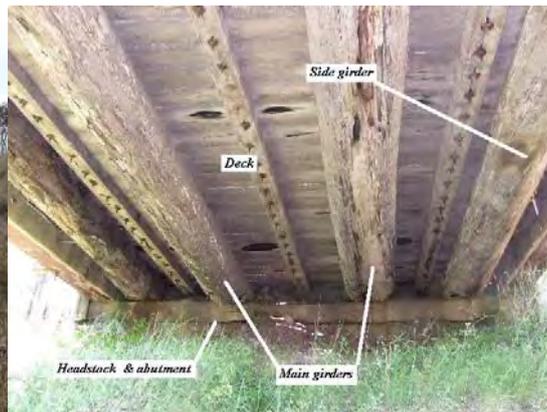
**Photo 4: Underside of Styx river bridge approach section**

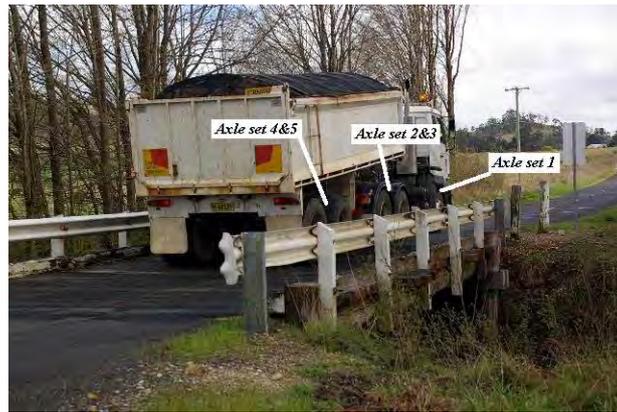
Based upon measurements made using a loaded truck of known gross mass and relationships between gross mass and axle load, Table 2 shows the deflection for the test trailer load and the inferred girder stiffness. Photo 7 shows the five axle test truck on the small timber bridge.

Photo 7: Stationary truck on bridge

The two system checks produced positive results. The first test involving loading the bridge statically enabled the stiffness to be identified as 750 kg/ mm which was typical for a girder in a satisfactory to good condition, depending on the species of timber. The second test, using a vehicle of known weight, showed that the system recorded data correctly. The result of a typical 24 hour period of activity is shown in Figure 2 and Table 4. Each bar in the graph of Figure 2 represents a vehicle and the height represents the vehicle weight category. For most of the time there were no vehicles but for 180 seconds in the 24 hours the bridge was deflected. The system was considered stable since for most of the time there was no measured deflection but for the short time vehicles were present, deflections were recorded. The vehicle activity was verified by visually observing that a record occurred each time a vehicle crossed the bridge.
